Sludge deposition and caustic embrittlement in the pre-mature failure of a waste heat boiler steel plate

D.J. Simbi and O.S. Chinyamakobvu*

Department of Metallurgical Engineering, University of Zimbabwe,
P.O. Box MP 167, Mount Pleasant, Harare, Zimbabwe.

A failure investigation of a welded waste heat boiler steel shell that developed transverse cracks was carried out in 1996 to determine the cause of failure as well as propose measures to be adopted to prevent similar failures occurring in the future. The boiler had been in service for several years before two cracks across two traversing circumferential welds were discovered on the underside during routine inspection. Chemical and metallographic analyses indicated that the boiler plate was made from a conventional C-Mn steel and that it was certainly suitable for the purpose. The boiler interior showed massive deposition of a calcareous sludge on the walls and tube bundles. This was attributed to an excessive use of sodium orthophosphate to reduce the hardness of the boiler feed water. The high levels of Na^+ and PO_4^{3-} ions found in both the sludge and boiler feed water analyses were taken as confirmatory evidence. Feed wa

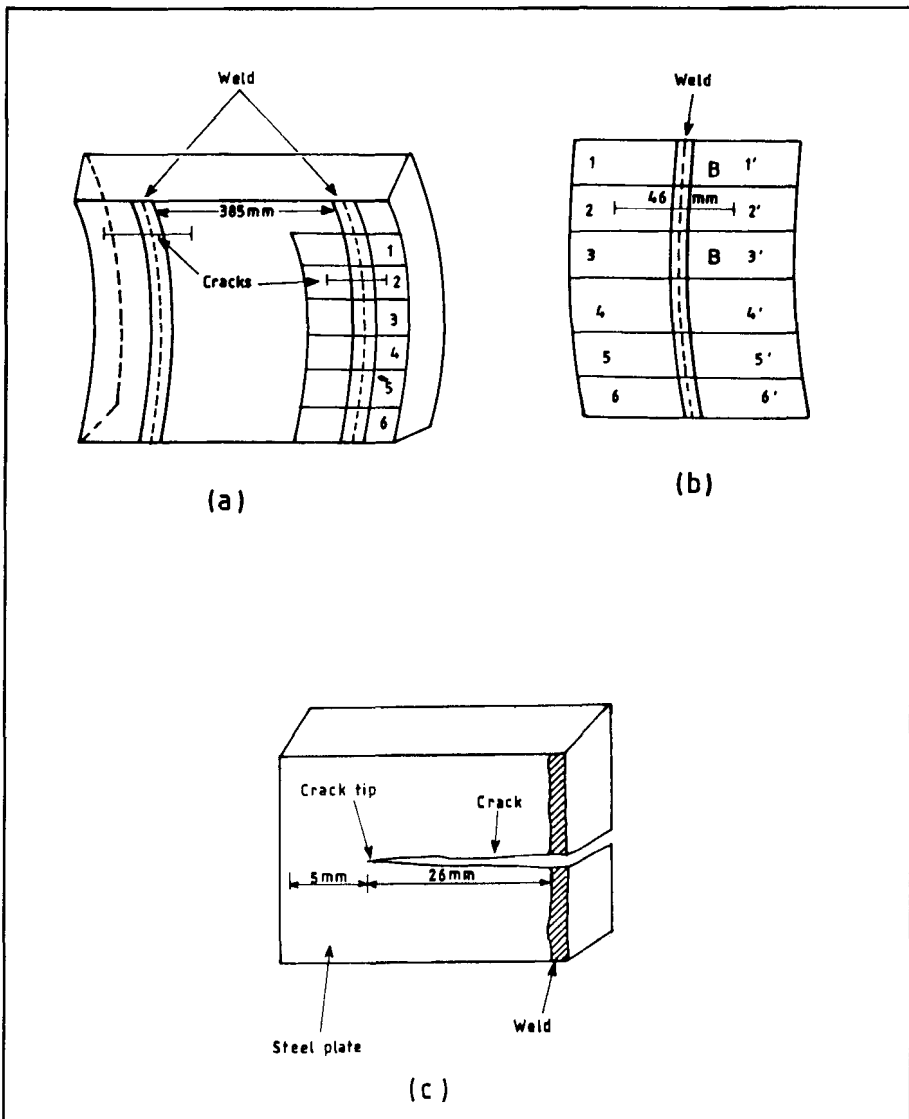
A welded steel plate containing the cracks was cut from the underside position of a waste heat boiler steel shell that developed transverse cracks across circumferential welds. A schematic representation of the positions of cracks with respect to the circumferential welds is shown in Figure 1a. A section containing the 46 mm long crack was cut into six segments and these were further subdivided into two along the weld (Figure 1b). The chemical composition of steel plate used to fabricate the boiler shell was determined quantitatively by spectrographic technique using a specimen labelled segment 1' (Figure 1b) in which the weldment and base metal were both present. The analysis obtained is given in Table 1.

Figure 1: Schematic representation of the boiler steel plate showing:

- (a) dimensions and position of two transverse cracks relative to the two circumferential welds.
- (b) section with the shorter of the two cracks sub-divided into six segments.
- (c) segment used in microhardness profile determination (see Figure 5).

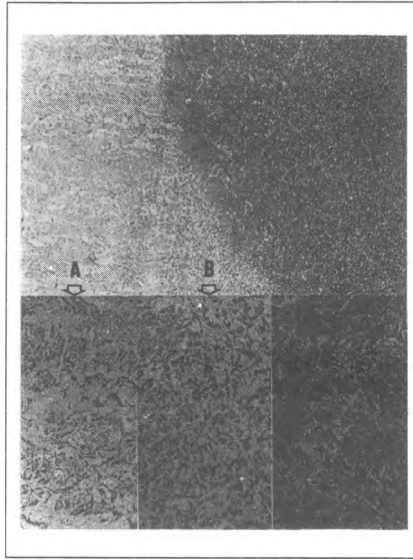
Examination of the weld/base metal interface, that is, the weld fusion zone in the unetched condition (see segments 1', 3' to 16' in Figure 1b) did not reveal the presence of such defects as slag inclusions or pores indicating that good welding practice had been followed. After etching the specimens in 2 percent nital solution, two different microstructures were, however, observed. These comprised 'white' or 'light' and 'dark' zones (Plate 1). When both zones were viewed at high magnifications, the 'white' zone was found to consist of columnar and equiaxed grains labelled A and B, respectively. The dark zone marked C in Plate 1 shows the microstructure to be martensite. In contrast, the base metal away from the weld fusion zone had a pearlite-ferrite microstructure with some of the pearlite appearing in clusters (Plate 2). It is most probable that in the dark zone of the weld/base metal interface, the pearlite was transformed into martensite/bainite, which is inherently brittle unless tempered. Microhardness measurements taken of these structures showed the following trends: 'white' zone, 213 to 219 HV and 'dark' zone, 234 to 253 HV. Plates 3 and 4 show the section of the crack previously identified as segment 2' (Figure 1b) viewed from the water-side in the unetched and etched conditions, respectively. Several cracks branching from the main crack can be seen (Plate 3). Blunting of the main crack tip is also evident. The mode of cracking appears to be predominantly intergranular (Plate 4). The observation of intergranular separation in the microstructure reported suggests the possible involvement of caustic embrittlement in the cracking process, a point that will be discussed later in the light of the chemistry of the sludge and boiler feed water.

Plate 1: Microstructure of the weld/base metal interface. x100

- (i) White zone: A — columnar and B — equiaxed grains. x200
- (ii) Dark zone: C — martensite. x200

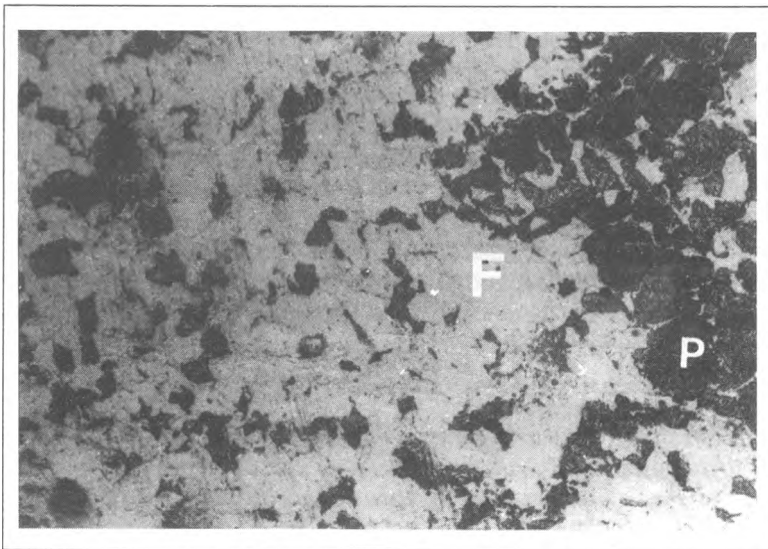
Plate 2: Microstructure of the base steel plate away from the weld. x100

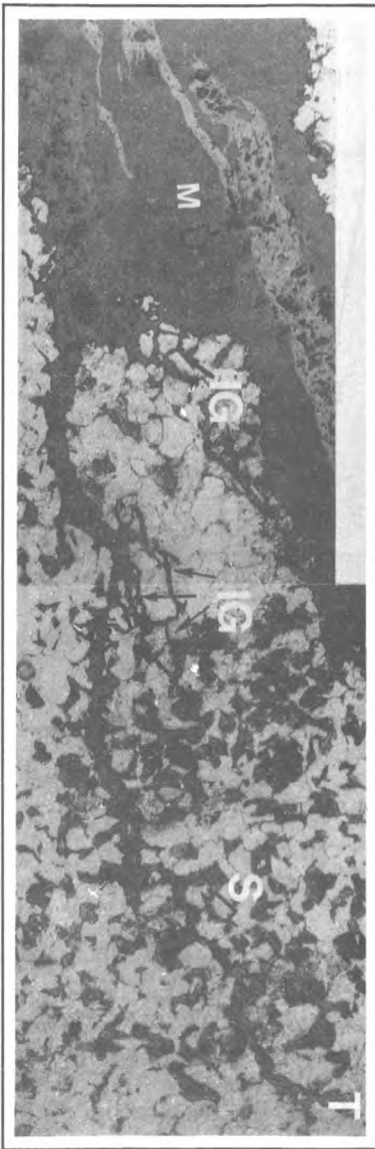
Plate 3: A section of the segment designated 2' in Figure 3b viewed from the waterside in the unetched condition showing: M-main crack; B and C-branching cracks; blunt crack tip. x100

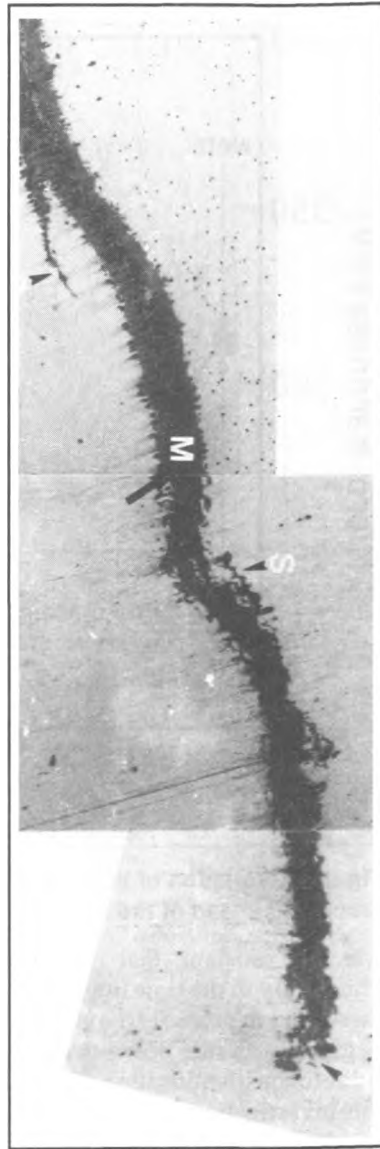
Plate 4: Microstructure of the main branching crack described in Figure 6 showing intergranular separation, S. x200

to over 200 000 ppm in the pores of the deposit adjacent to the boiler wall surface. In caustic embrittlement, crack propagation is generally intergranular. In the present investigation, high pH and caustic alkalinity reported in the period prior to the discovery of the two transverse cracks point strongly to the involvement of caustic embrittlement in the cracking process. The observation of intergranular separation in the microstructures adjacent to the crack paths provides further confirmation of the suggested failure mechanism.

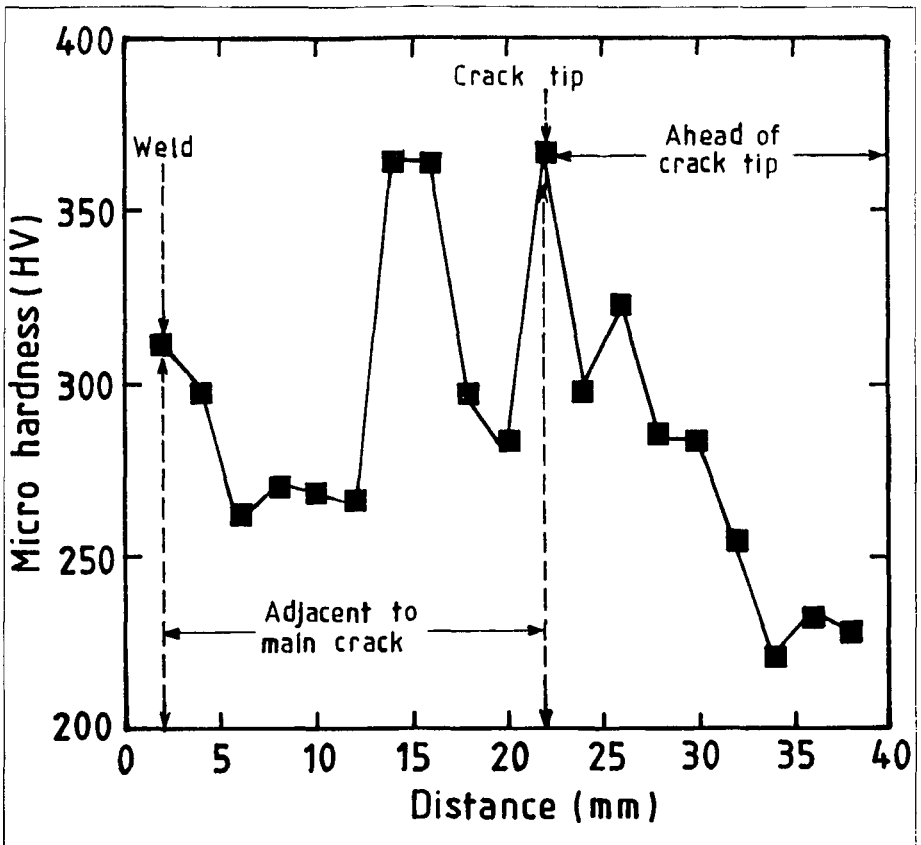
Microhardness measurements taken on the segment identified as 2 in Figure 1b show the hardness values adjacent the main crack path ranging between 254 and 363 HV. A plot of the Vickers hardness, HV, versus distance from the weld to a point ahead of the crack tip is shown in Figure 2. The higher peaks in the curve were found to correspond to areas where there was a relatively high density of pearlite structures in the area in or adjacent to the crack path. Ahead of the crack tip, the hardness was found to drop rather rapidly down to a value of approximately 225 HV as the distance from the crack tip was increased. This value is in agreement with the general hardness of 220 HV for this material as reported earlier.

Figure 2: Variation of Vickers microhardness with distance adjacent the main crack and ahead of the crack tip.

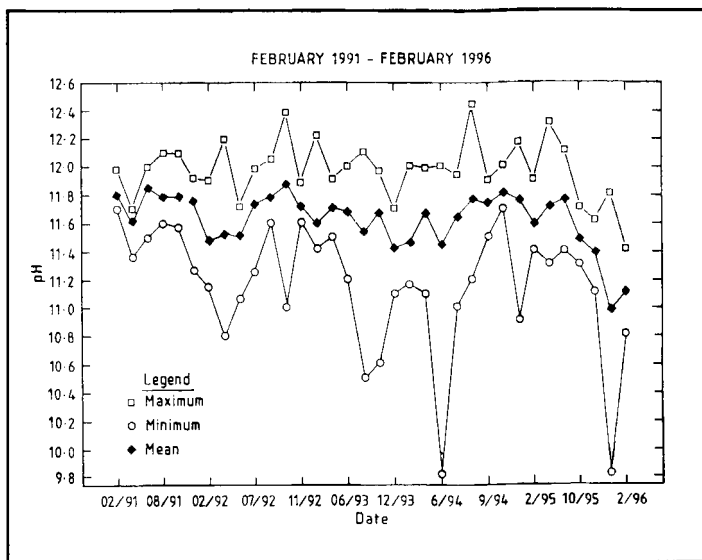
was not constant, that is, it varied from three to seven months. The lack of uniformity in the time intervals between plotted readings makes it difficult to use these data to properly monitor boiler feed water quality. This obviously affects the degree of accuracy of any corrective measures likely to have been taken. The period prior to the identification of the cracking problem which seems most significant in this investigation lies between June 1994 and February 1996. An analysis of the pH graph during this period, for example, shows that the latter was generally maintained on the high side with maximum values of around 12.4 being reported (Figure 3). A pH range of 8 to 11 is suggested in the literature [Brown, 1971]. The optimum pH level for a system which is established by experience for each installation is the level that keeps amounts of corrosion products of iron in the boiler at a minimum. However, with inadequate water treatment practice or lax pH control, there is potential for excessive water-side corrosion, in particular on boiler tube surfaces.

Figure 3: Variation of boiler feed water pH during the period February 1991 to February 1996.

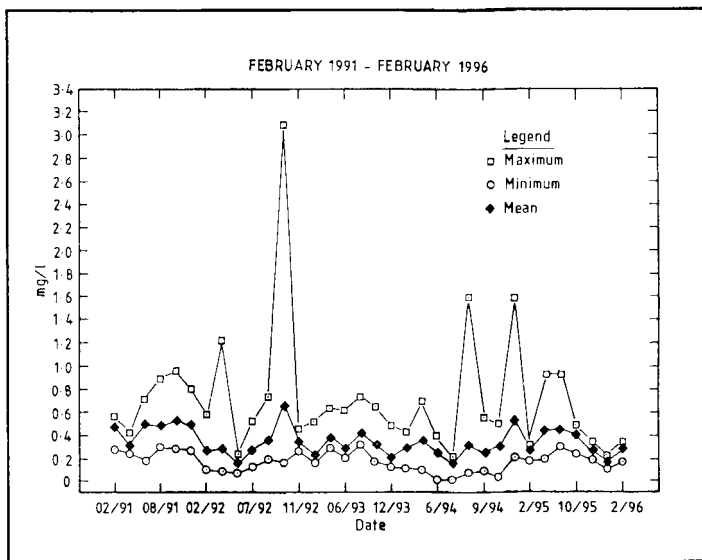
Figure 4: Variation of boiler feed water caustic alkalinity during the period February 1991 to February 1996.

The corresponding alkalinity, chloride and phosphate values (Figures 4 to 6) for the period under consideration were within acceptable ranges. Conductivity and total dissolved solids on the other hand were generally on the high side (Figures 7 and 8).

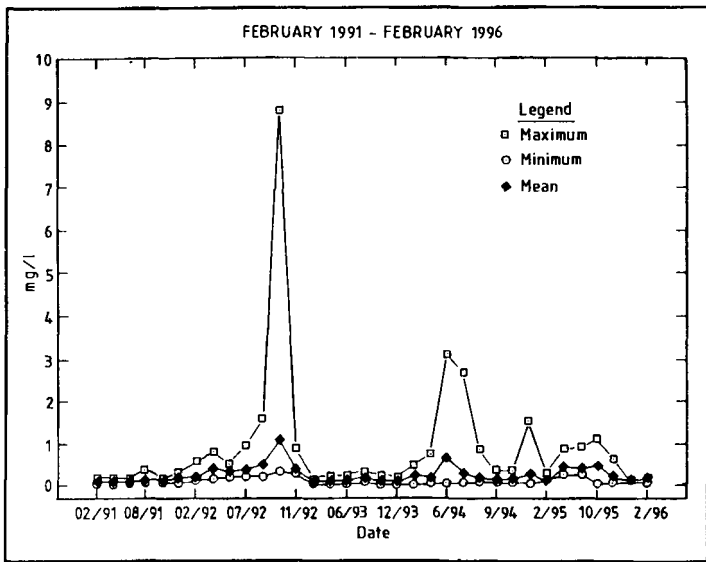
Figure 5: Variation of boiler feed water chloride content during the period February 1991 to February 1996.

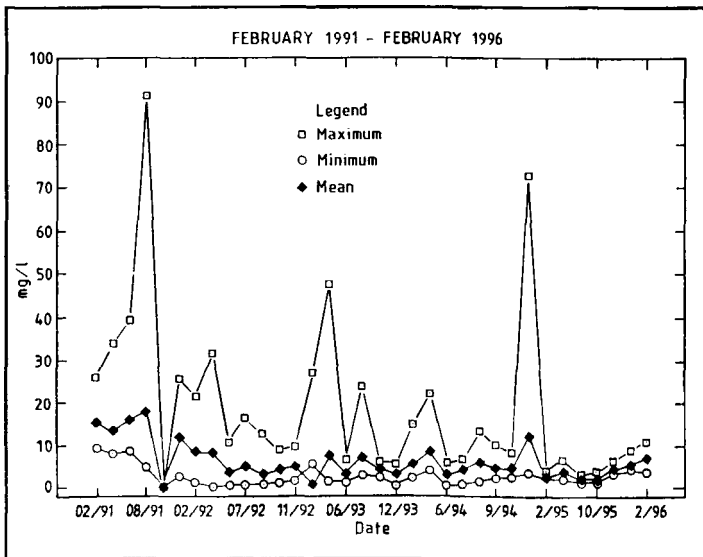
Figure 6: Variation of boiler feed water phosphate content during the period February 1991 to February 1996.

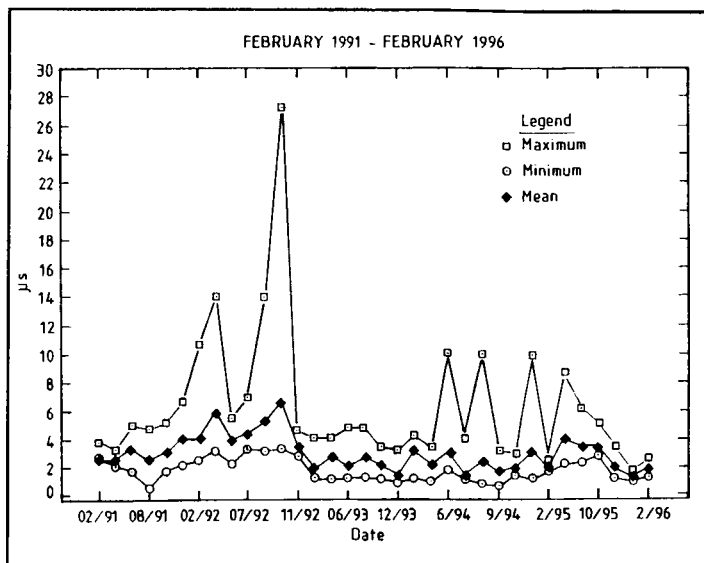
Figure 7: Variation of boiler feed water conductivity during the period February 1991 to February 1996.

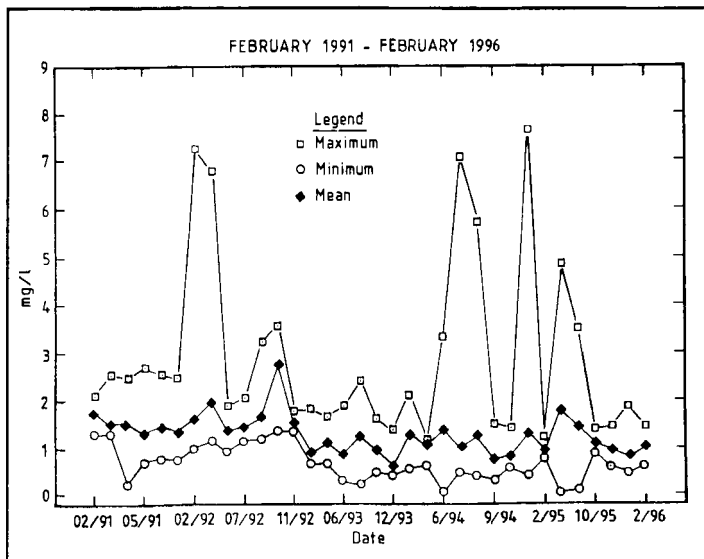
Figure 8: Variation of boiler feed water total dissolved solids during the period February 1991 to February 1996.
